Elliott Bay/Duwamish Restoration Program:
Intertidal Habitat Projects Monitoring Report
2010 Report

Elliott Bay/Duwamish Restoration Program: Intertidal Habitat Projects Monitoring Report

2010 Report

**Prepared By:
U.S. Fish and Wildlife Service
Washington Fish and Wildlife Office**

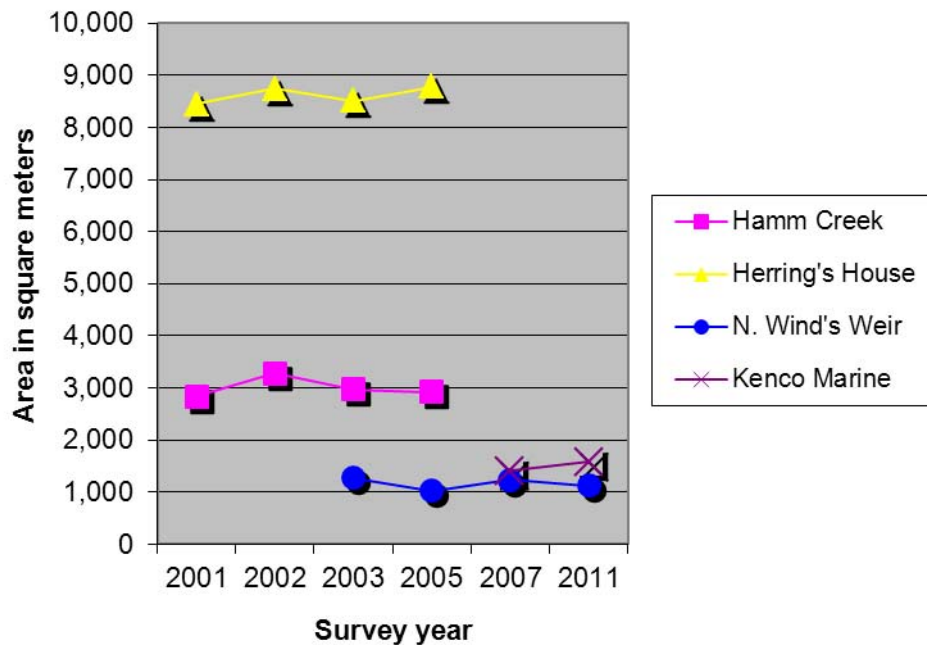
The intertidal area estimates for the restoration sites are provided in **Figure 6** from the data in **Table 2**.

Figure 6. Intertidal area measurements by survey year for restoration sites.

The intertidal area at North Wind's Weir (NWW) has remained at 0.3 acre since construction. NWW decreased in 2011, however was within the previous years' range of values. The small difference in estimated intertidal area from 2003 to 2011 (-248 m²) is likely due in part to random error and measurement error. From visual observations, the site continues to appear stable with no noticeable signs of erosion or deposition of sediments. The intertidal area estimate does not meet Physical Success Criterion 1 of 0.9 acre (90 percent of 1 acre) for the site. The monitoring plan (EBDRP 2000) states that the entire area of the North Wind's Weir site is 1 acre in size. The 0.7-acre difference in intertidal area

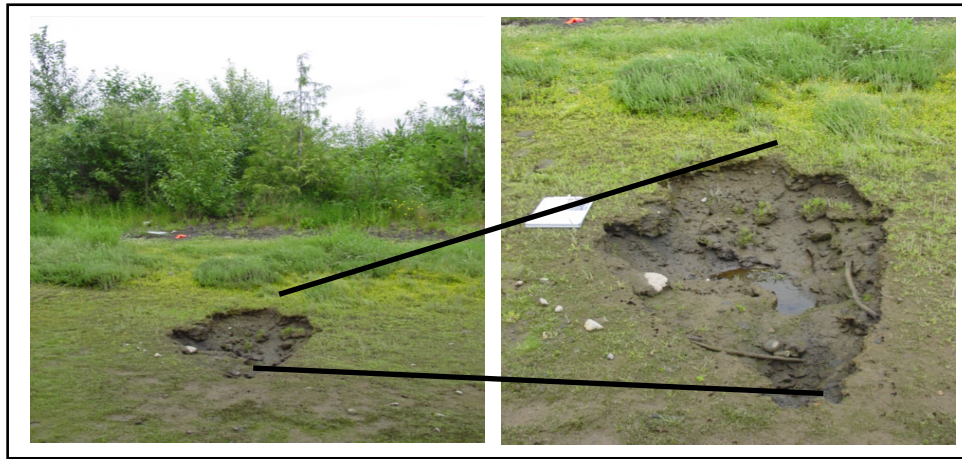
The only sign of erosion-related change at Herring's House was the 'sink hole' first observed in the intertidal area in 2005 (**Figure 7**). This sink hole doubled in size to approximately 1.5- meters wide by 3-meters long in 2007. Subsequently, in 2010 the sinkhole appeared to have filled in some from 2007. Additional erosion was noted near the end point of transect 1 (**Figure 8**) The North Wind's Weir site has remained stable since construction was completed. No signs of erosion were seen at the Kenco Marine site.

Figure 7. Sink-hole erosion located in the intertidal area at Herring's House restoration site in 2005.

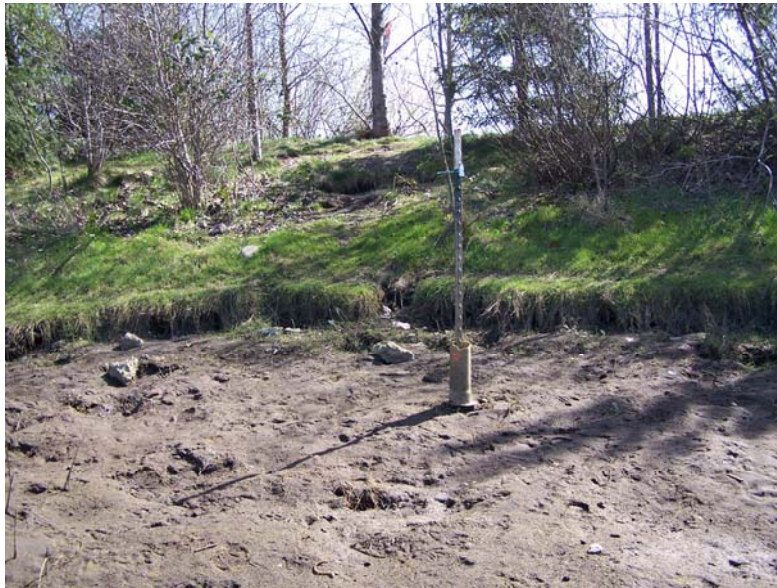
Figure 8. New erosion in the intertidal area at Herring's House restoration site in 2010.

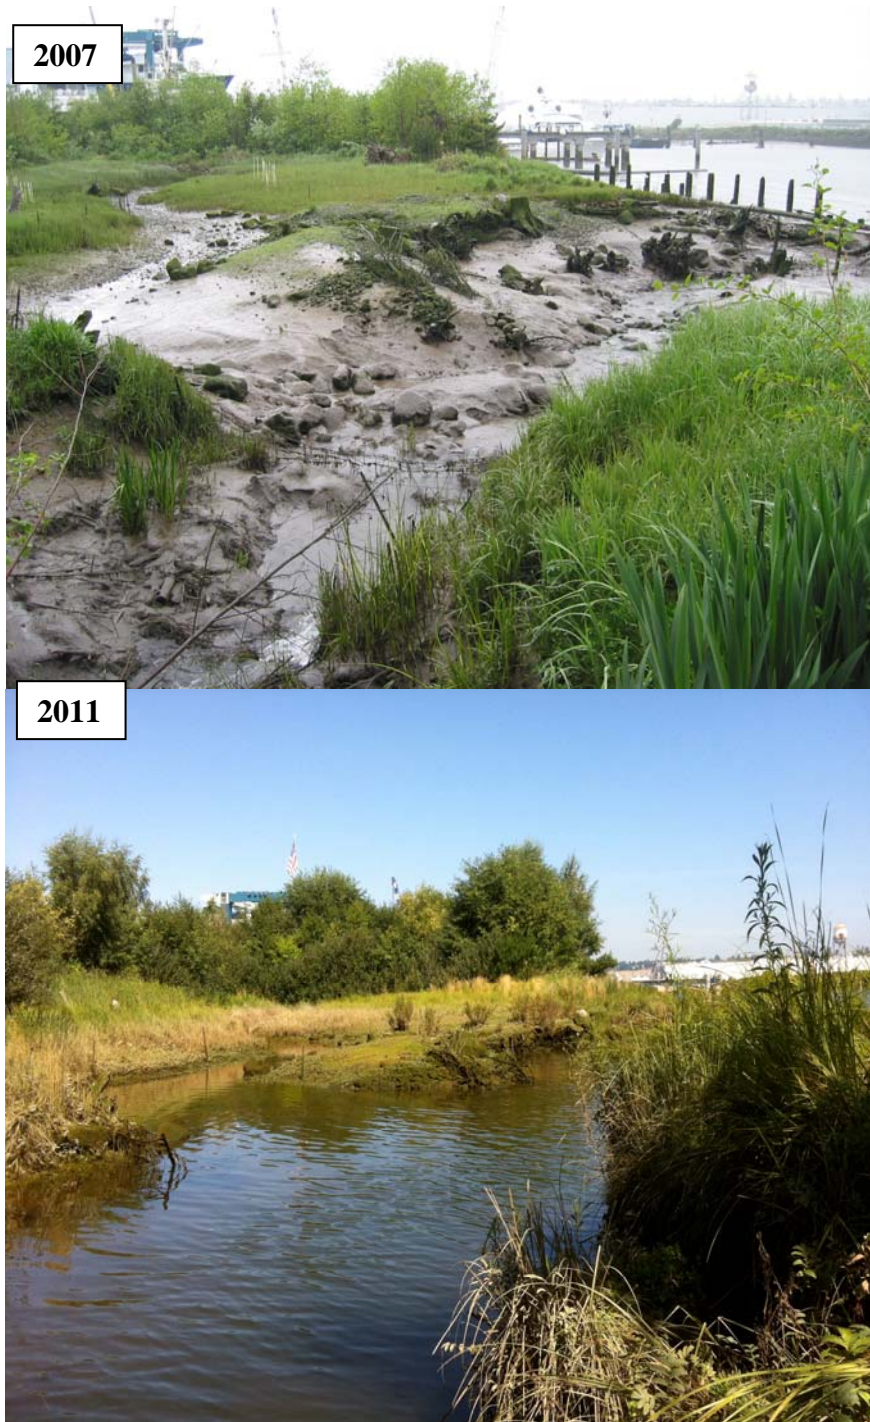
Major erosion occurred at the Hamm Creek restoration site during winter storm events in 2006/2007. In addition, beaver dams along the creek have caused water to back up and create a new creek channel cutting through the berm that previously separated the freshwater and saltwater marshes (**Figure 9**). The County currently has permits pending to restore the site to its prior condition. This work had not been done at the time of the 2010 monitoring. The stream channel appeared fairly stable from where it was in 2007. The marsh edge along transect 3 showed signs of erosion (**Figure 10**) and transect 1.

Figure 9. Stream channel changes and erosion at Hamm Creek in 2007 and 2011.

The Hamm Creek site was not constructed with riprap or armoring where the creek flows into the Duwamish River. The confluence of the creek with the Duwamish River is a dynamic area and the creek's course continues to meander. After the erosion event in 2002, King County strategically placed large boulders, cobble, and root wads along the north bank of the creek to protect the eroding peninsula and slow the rate of erosion at the site. In 2005 that erosion appeared to have slowed considerably. However, in 2007 there was further erosion on the north bank at the mouth of the creek and considerable erosion caused by the creek cutting a new channel through the freshwater marsh. In 2010 there was erosion along the shoreline.

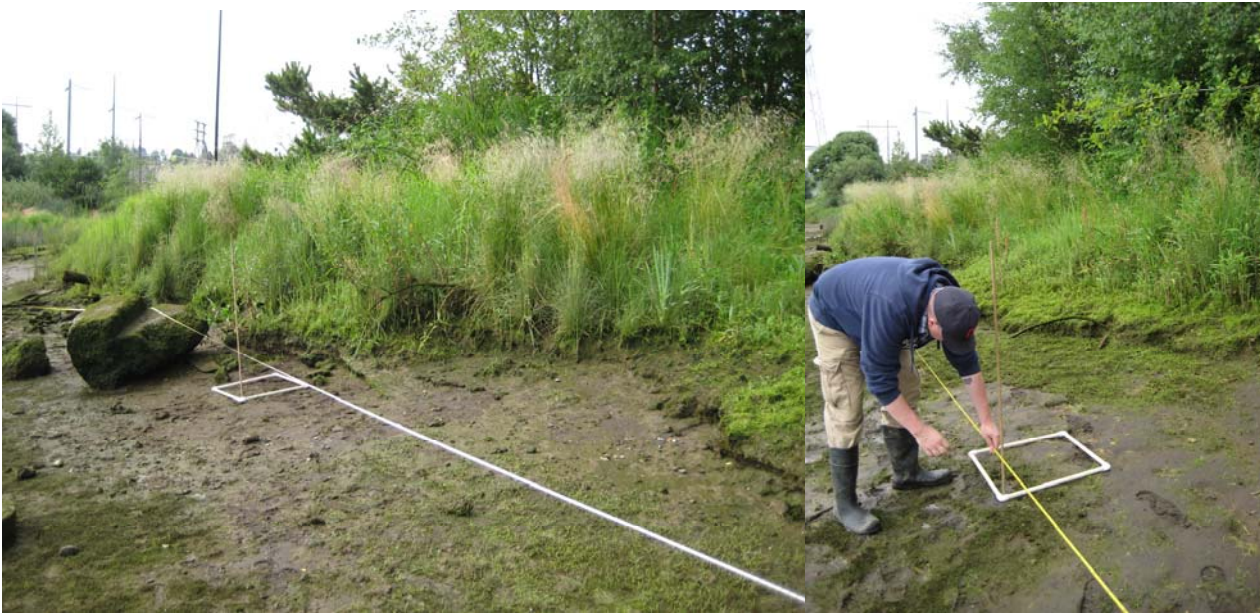
Figure 10. Shoreline erosion at Hamm Creek near transect 3 in 2010.

Herring's House, North Wind's Weir, and Kenco Marine meet Physical Success Criterion 3. The Hamm Creek site has not undergone reconstruction. The majority of the site appears stable when compared to its condition in 2007, though there is some erosion along the shoreline. Due to shoreline erosion it does not yet meet Physical Success Criterion 3.

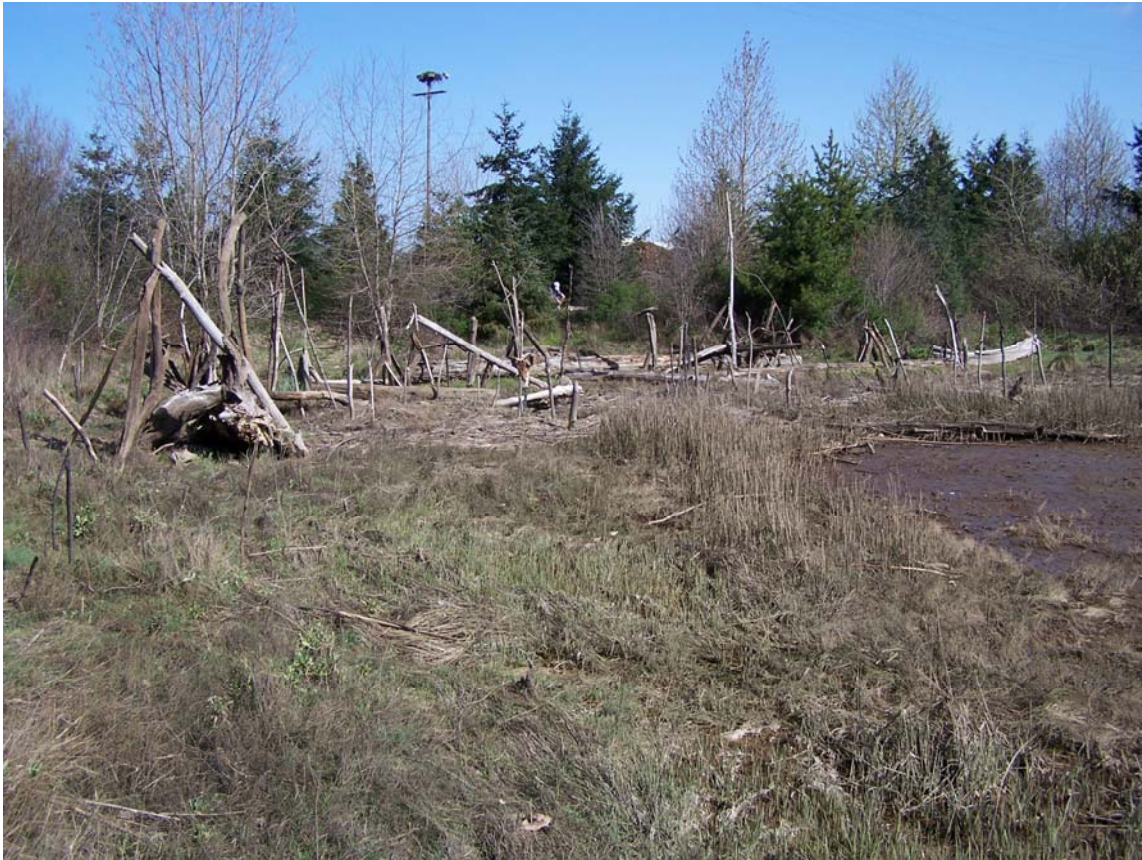
Figure 11. Moved and stacked driftwood at Herring's House restoration site.

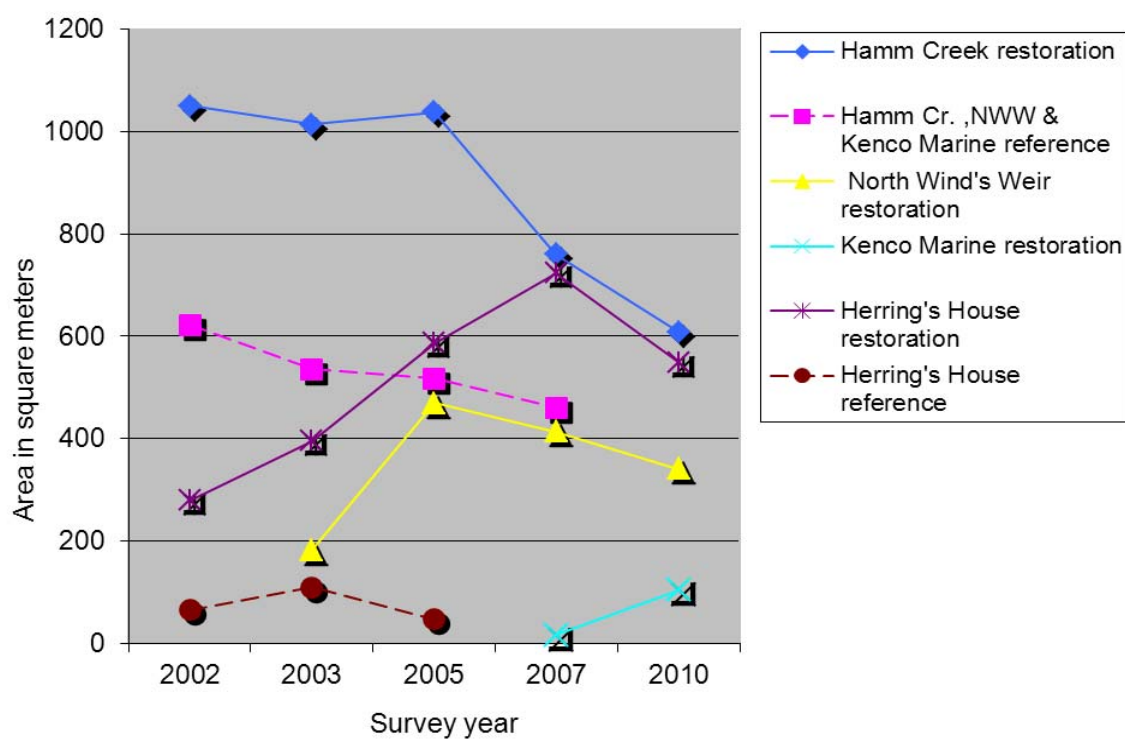
Figure 14. Comparison of the total area of marsh vegetation patches (Lyngby's sedge and bulrush) at the restoration sites and their associated reference sites by survey year.

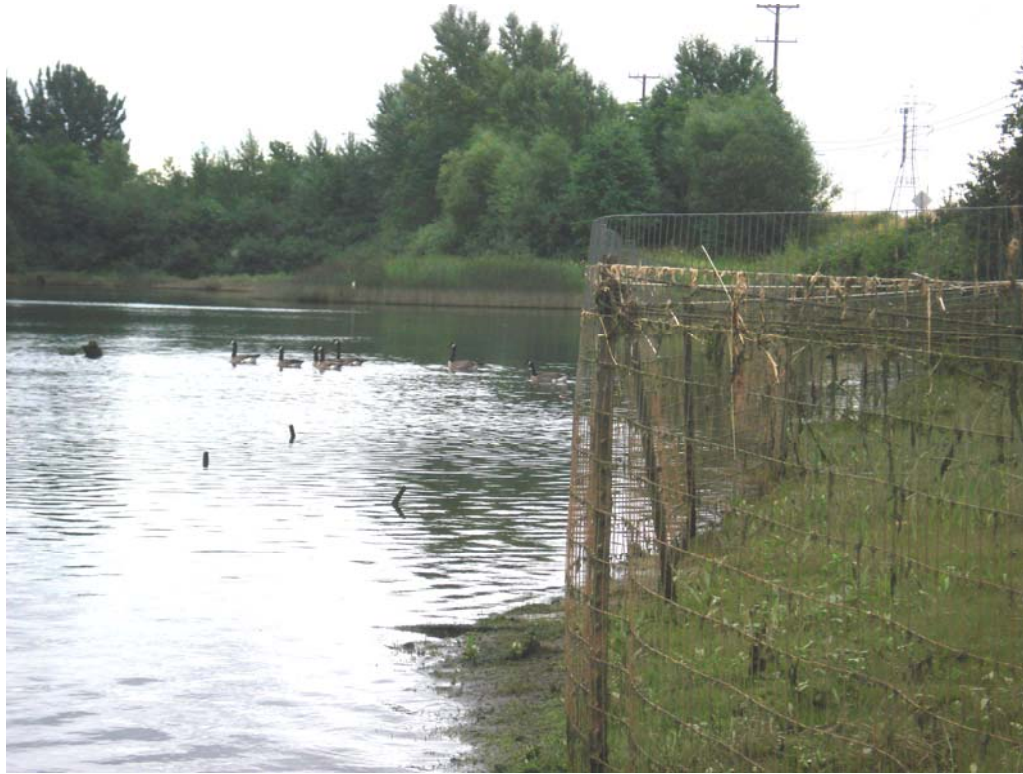
The areal extent of marsh vegetation at Kenco Marine restoration site was 0.06 acre. This marsh was initially planted in 2006 and re-planted in the spring of 2007. It was noted during monitoring that the goose excluder fences were not completely successful. Waterfowl were observed swimming over the outer fence at high tide and foraging within the restoration site. During site reconnaissance in March 2010, the goose exclusion was in total disrepair; however in July 2011 it had been repaired and was noted to be effective (**Figure 15**).

Figure 15. Goose excluder fencing at Kenco Marine and Canada Geese foraging outside.

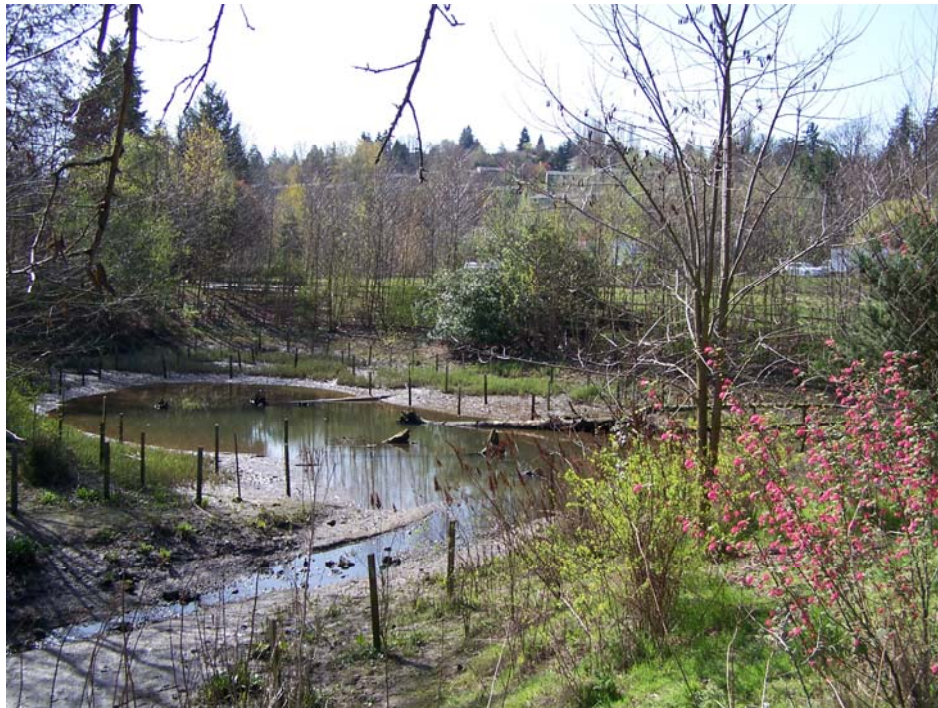
At North Wind's Weir patches of Lyngby's sedge continue to appear to encompass most of the intertidal area above standing water in the basin. The total area of Lyngby's sedge patches increased by 158 percent in 2005, decreased by 12 percent in 2007, and decreased by 17% in 2010. Random error and measurement error likely account for a portion of the decrease noted between 2005, 2007, and 2010. The Lyngby's sedge marsh at the site still appears to encompass the entire suitable habitat at the site (**Figure 13**). In 2007 the marsh declined at a similar rate as the reference site. This comparison was not possible in 2010, due to the elimination of the reference site (see discussion, page 3). These changes make it difficult to assess whether the site meets BSC1.

Figure 16. Lyngby's sedge marsh at North Wind's Weir.

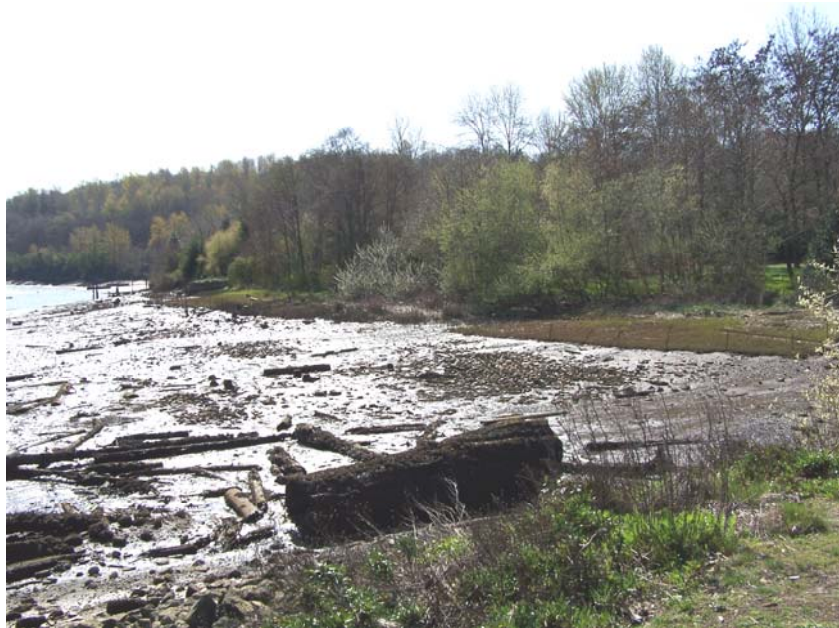
Figure 17. Marsh plantings and goose excluder fencing at Herring's House reference site looking south from Herring's House.

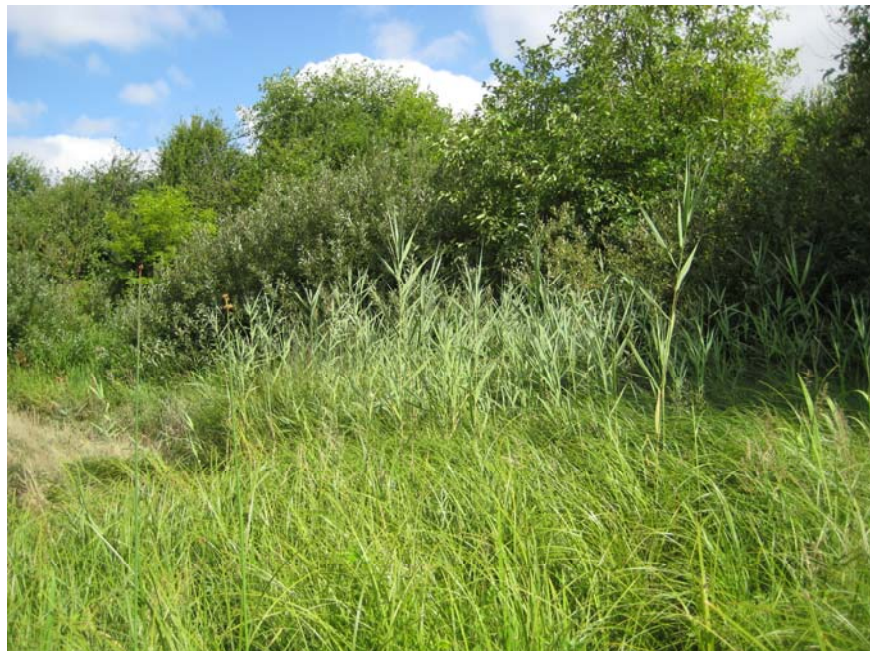
In 2005, reed canarygrass (*Phalaris arundinacea*) was found in a transect plot at Hamm Creek. Of the four species listed in the EBD RP monitoring plan as invasive species of special concern, reed canarygrass is the only species of special concern found in marsh transects at the restoration and reference sites since 2001. In 2007, several species of special concern were noted at the Hamm Creek restoration site growing in areas not sampled by the transects. A clump of common reed (*Phragmites communis*) was noted in the upper marsh and was still there in 2010 (**Figure 18**). A clump of reed canarygrass (*Phalaris arundinacea*) was growing near the start of transect 1, and several others were located at the upper edge of the marsh and were still there in 2010 (**Figure 19**).

Figure 18. Common reed in the upper marsh of Hamm Creek.

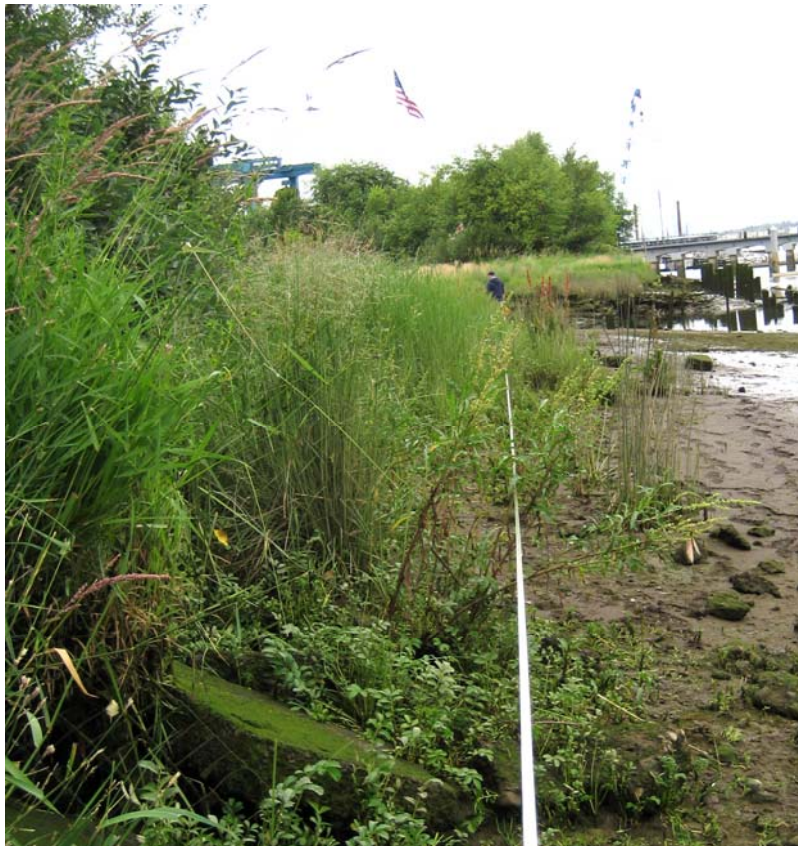
Figure 19. Reed canarygrass (on left) growing near Transect 1 of Hamm Creek upslope from the brackish water.

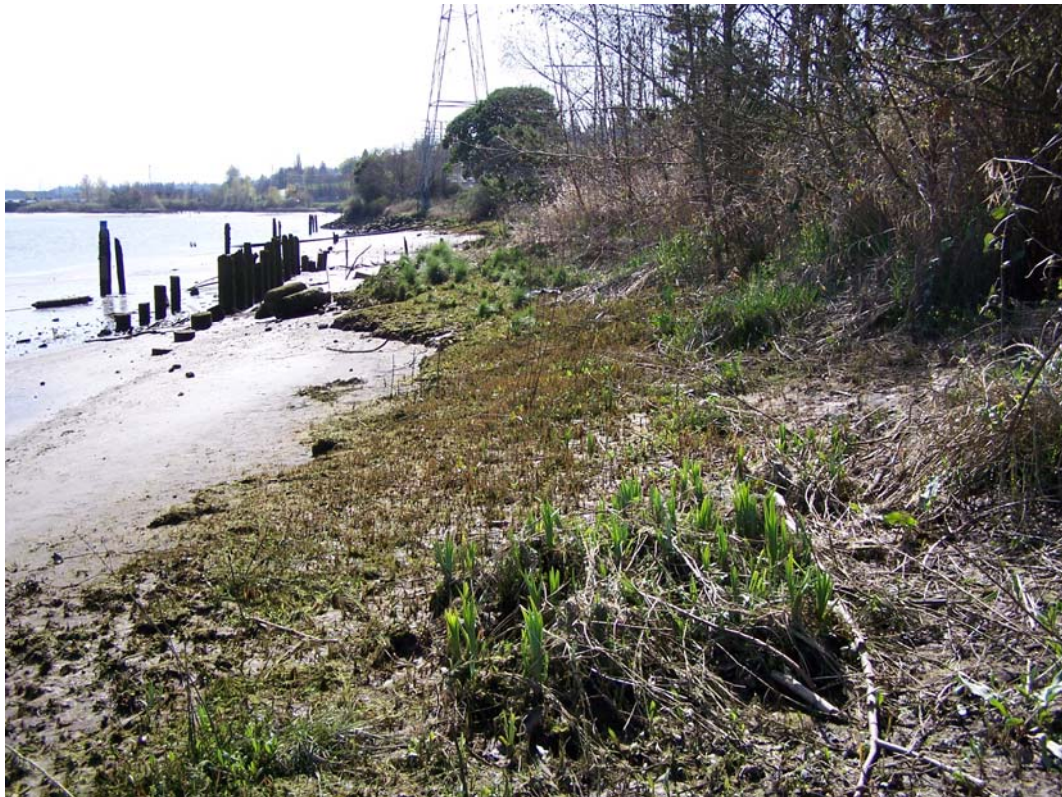
During a site reconnaissance visit in May 2007, it was noted that some invasive species removal had occurred. Numerous clumps of yellow flag iris (*Iris pseudacorus*) had been removed from the Hamm Creek marsh and were piled in various areas. Yellow flag iris was still present at the Hamm Creek site in 2010. It was seen along transect 3 (**Figure 20**).

Figure 20. Yellow flag iris at Hamm Creek in 2010.

As mentioned in the report, other invasive species were noted during the 2007 monitoring event and again in 2010, besides the four invasive plant species of special concern listed in the EBD RP monitoring plan. These species included yellow flag iris and perennial pepperweed. Yellow flag iris is listed as a Class C noxious weed and perennial pepperweed is listed as a Class B weed in Washington State. It will be critical for future success of these sites to control occurrences of these invasives while they are relatively small in number and while control methods have a negligible impact on site restoration efforts.

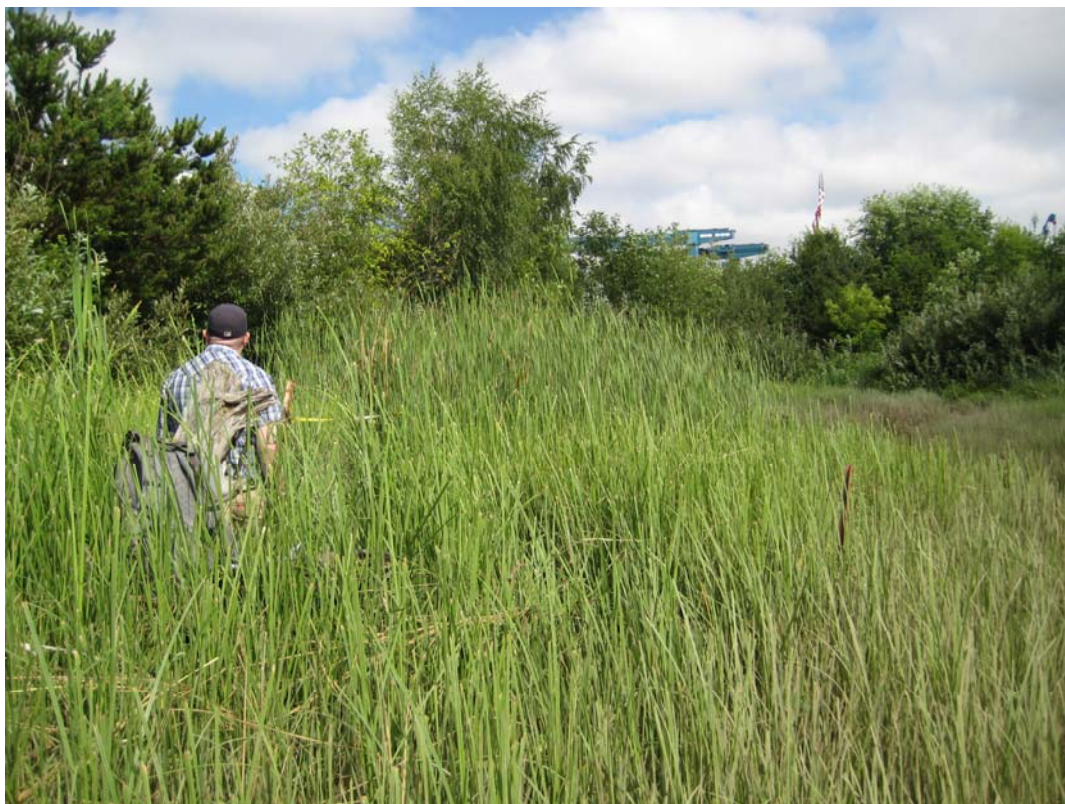
In 2007, linear leaved cattail was noted near the previously established end of transect 2 (since washed out) and above transect 4. In 2010 patches were still prevalent along transect 4 (**Figure 21**). In 2010, a patch of linear leaved cattail was also noted at North Winds Weir, near the end of transect 2. Single occurrences of perennial pepperweed (*Lepidium latifolium*), a state-listed species to be controlled, were found at several of the sites and removed as feasible.

Figure 21. Cattail near the end of transect 2 and above transect 4 in Hamm Creek.
